Tuning a 2.4 Meter Telescope... Blindfolded

^aUniversity of California Observatories, Santa Cruz, CA 95064 USA

ABSTRACT

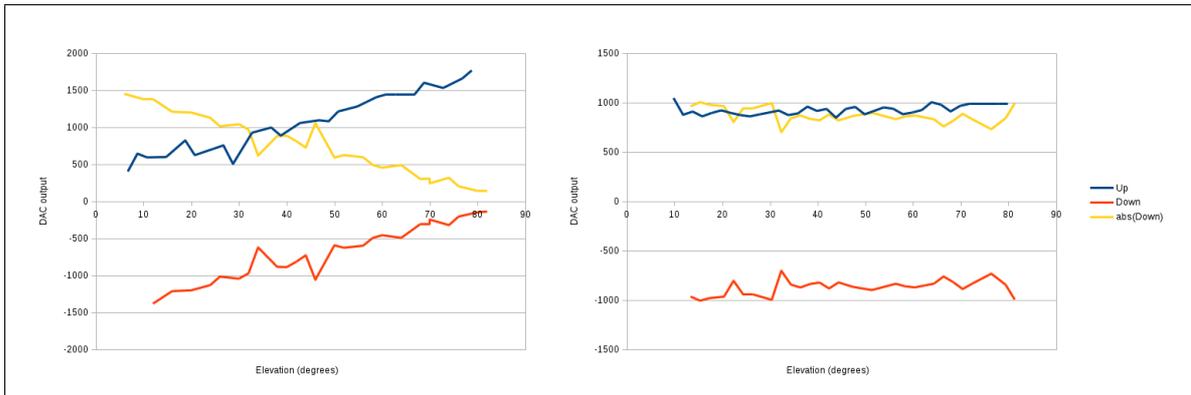
Figure 1. DAC output at constant velocity, before and after balancing the telescope

The initial test of this procedure demonstrated an observable imbalance, as seen in figure 1. The slope of the line indicates the nature of the imbalance, if any; when the telescope is heavy on the bottom, the lines will have a positive slope; when heavy on the top, a negative slope; when perfectly balanced, the slope will be zero.

Each adjustment to the weights at the top end of the telescope tube was followed by a data collection pass. After several iterations, the telescope was considered successfully balanced; the resulting data set is shown in figure 1. A small slope is present in the final data, indicating that the telescope remains ever so slightly heavier on the bottom side. This residual imbalance is not sufficient to accelerate the telescope when it is unpowered, and is easily handled by the PID control loop.

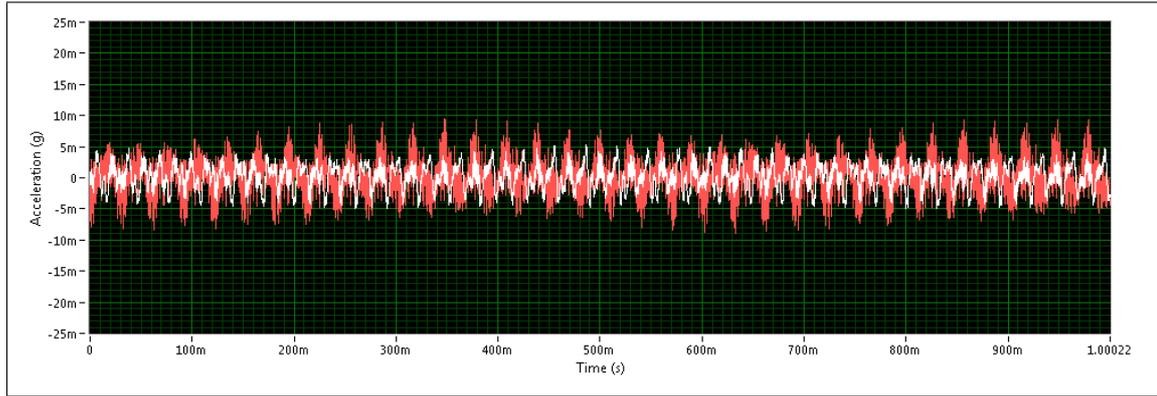
Figure 2. Acceleration signature of an oscillation while holding position

A simple early oscillation is shown in figure 2. Each axis is represented by its own color: the elevation axis is in white, and the azimuth axis is in red. When the acceleration is graphed over time, a strong oscillation shows what appear to be standing waves, harmonic structure in what would ideally be a flat line. This specific oscillation occurred while the telescope was servoing to hold position while pointed at the zenith.

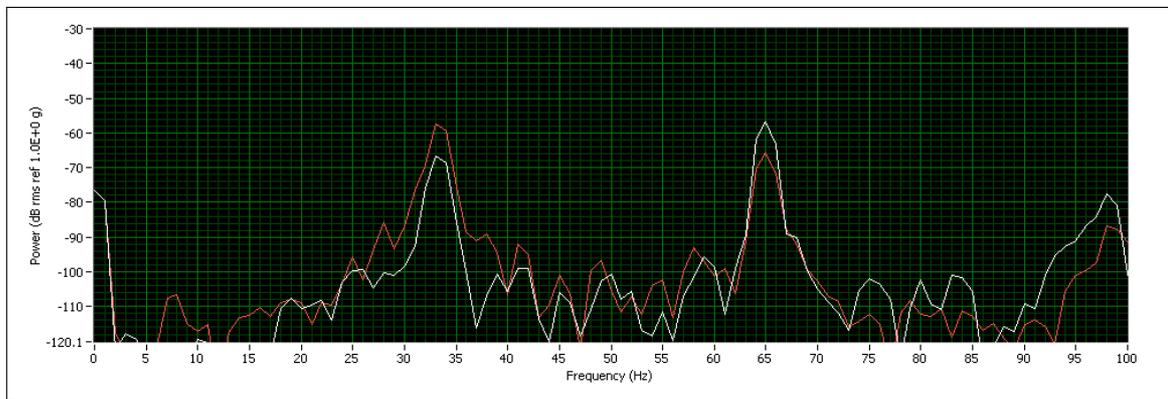
Figure 3. Power spectrum of an oscillation while holding position

The power spectrum for the same oscillation is shown in figure 3. The oscillation appears to be driven by the azimuth axis in the 30-35 Hz range, and is coupling into the elevation axis; the entire structure is then resonating at or near even multiples of the base frequency. With a peak power above -60 decibels, this oscillation was audible to personnel in the dome. Though this oscillation was being driven by the servo control loop, it was amplified by a mechanical resonance in the telescope yoke.

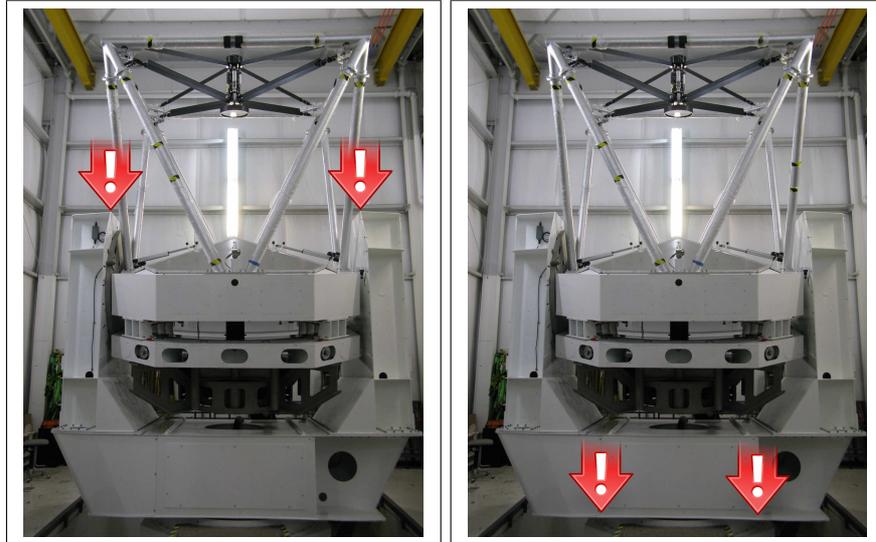
Empirical identification of mechanical resonances was also possible with the accelerometer measurements. The procedure, though crude, was effective: walk around the telescope, and bang on different components of the structure. When something rings, check the power spectrum to identify the resonant frequency. Two major resonances were identified in this fashion: one was a large steel plate at the base of the telescope, just above the azimuth bearing; this plate exhibited a strong resonance at 45 Hz. The second resonance was a matched pair of large steel plates in the telescope yoke, on either side of the telescope tube (see figure 4), with a strong resonance between 25-35 Hz. These resonances would have been readily identifiable via swept sine analysis, had a full servo analysis been performed.

Figure 4. Location of metal plates subject to resonances at 25-35 Hz (left) and 45 Hz (right)

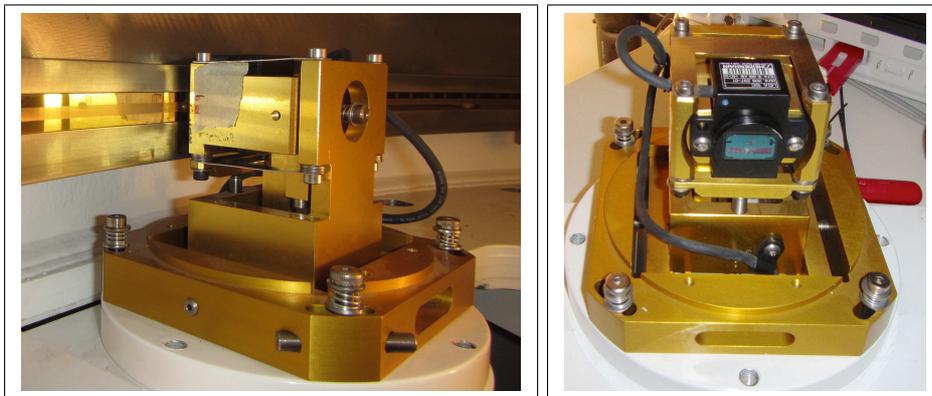
Figure 5. Heidenhain LIDA 10C read head on its custom EOST mounting assembly

The EOST encoder mounting assembly (see figure 5) is designed to place the read head behind a bulkhead and facilitate precise adjustments to the alignment of the read head from the bottom of the mechanism outside the plate. Three flaws in the encoder mounts had to be addressed in order to successfully align the read heads. The

first is that the vertical positioning springs return to center, and the adjustment screw can only push the head up, away from the center; to work around this, the spring plates were bent so that the resting position was below center, allowing a full range of adjustment through the center. The second flaw is that the yaw position at the head is held by friction, and will move when adjusting pitch and roll. The yaw adjustment is made by rotating the whole base of the mount in its roughly six inch mounting hole; this adjustment is made with opposing set screws that push on one of the four mounting bolts. Making yaw adjustments slides the base around, in the process changing the distance between the encoder tape and the read head, which then requires readjusting the distance between the read head and the encoder tape. There was no direct fix for the second flaw, thus requiring another check of the yaw after adjusting the pitch or the roll. The third flaw had several of the read heads hard against the lower spring plate, preventing both pitch and roll adjustments; in one case, this required the installation of washers to create a gap for the read head, in others its was sufficient to loosen the two screws holding the read head, push the read head away from the spring, and re-tighten.

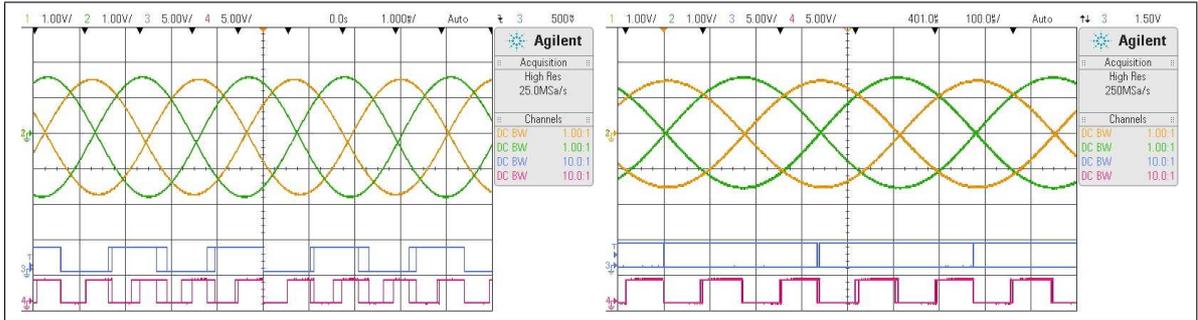
In figure 6, the scope is set up to alternately trigger on two points 180 degrees out of phase with each other, so that the different pulse widths are superimposed. Note that the sine wave crossings of the overlaid

Figure 6. The upper traces are the analog 0 and 90 degree output signals provided by the PWM-9. The lower traces are the 400x quadrature output of the interpolator, divided down to give an observable number of transitions on the scope. These graphs show readings from before and after adjustments to the mechanical alignment.

quadrature signals are not necessarily occurring near zero, some occur well below zero. This is direct evidence of the nonlinearity from the encoder read head. The square waves shown are from our digital breakout board, and represent the interpolator outputs divided down by one of several fixed factors. In the case of figure 6, the square wave at the bottom of each image is the interpolated signal divided down by a factor of 100. Thus, one cycle of the encoder signals corresponds to four cycles of the divided-down interpolated output. Any misalignment of the square wave transitions is likewise direct evidence of the nonlinearity from the encoder read head.

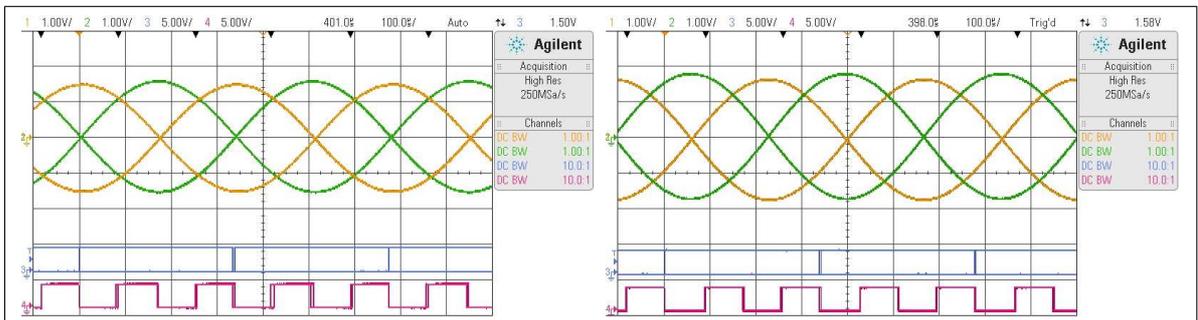
With the encoder read heads at their best adjustment there still was a significant nonlinearity out of the interpolator. Documentation was not readily available on the function of the two potentiometers inside the interpolator; when contacted, Heidenhain declined to clarify the matter, stating that if adjustments were required, the devices should be shipped back to the factory for service. Experiments conducted by EOS at their facility in Australia indicated that it should be safe to proceed with adjustments to the potentiometers, though it was not obvious there would be any significant benefit.

Figure 7. The signals shown are the same as figure 6. These graphs show readings from before and after fine tuning of the interpolator potentiometers.

The two potentiometers are labeled ‘0 degrees’ and ‘90 degrees’; in some of the interpolators, these had been set far from the center position. Empirical testing showed that adjustments did have an impact on the measured nonlinearity. Our final procedure was to center these potentiometers, mechanically align the head for best readings on the PWM-9, and then tweak the potentiometers to remove the residual nonlinearity observed via the divided interpolator output. Adjusting these potentiometers while watching the non-linearity on the scope allowed a nearly perfect linearity out of the interpolator (see figure 7). This success was backed up by the results under servo control, with residual oscillations occurring at such low power that they did not impact the overall performance of the telescope in any significant fashion.

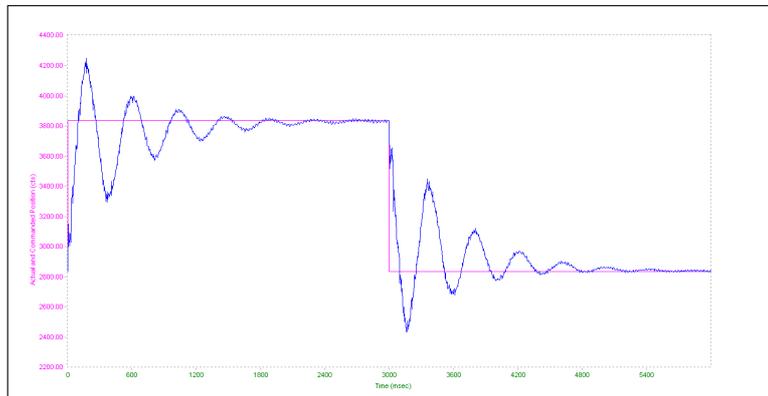
Figure 8. Step response test, showing ringing and high-frequency instability

The tuning tools also include calculators for low-pass frequency filters, which proved early on to be extremely effective in knocking down high-frequency oscillations observed on the accelerometers. The frequency selected for the low-pass filter was essentially a free parameter; it had to be selected before any further adjustments were made, and if it was changed, it proved necessary to start the tuning procedure from scratch. After probing a variety of filter frequencies between 4 Hz and 40 Hz, we settled on 9 Hz for the azimuth axis, and 12 Hz for the elevation axis.

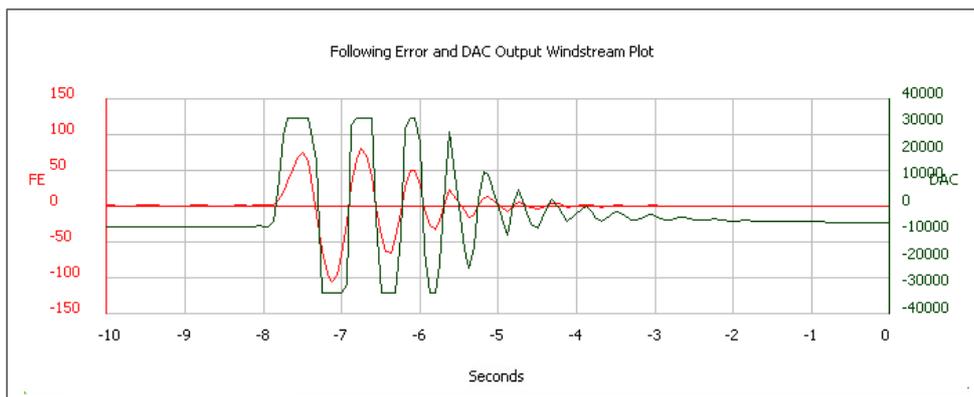
Figure 12. Poor correction of a large impulse to the elevation axis; note the DAC output clipping at +/- 32k
