Mt. Hamilton Optics Cleaning Trip

David Hilyard and Brian DuPraw
2/13/13

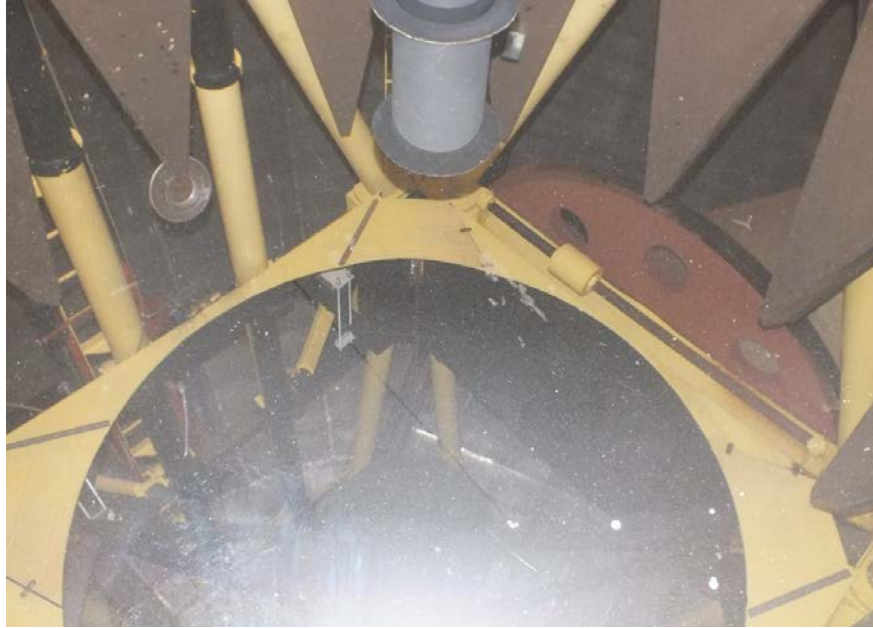
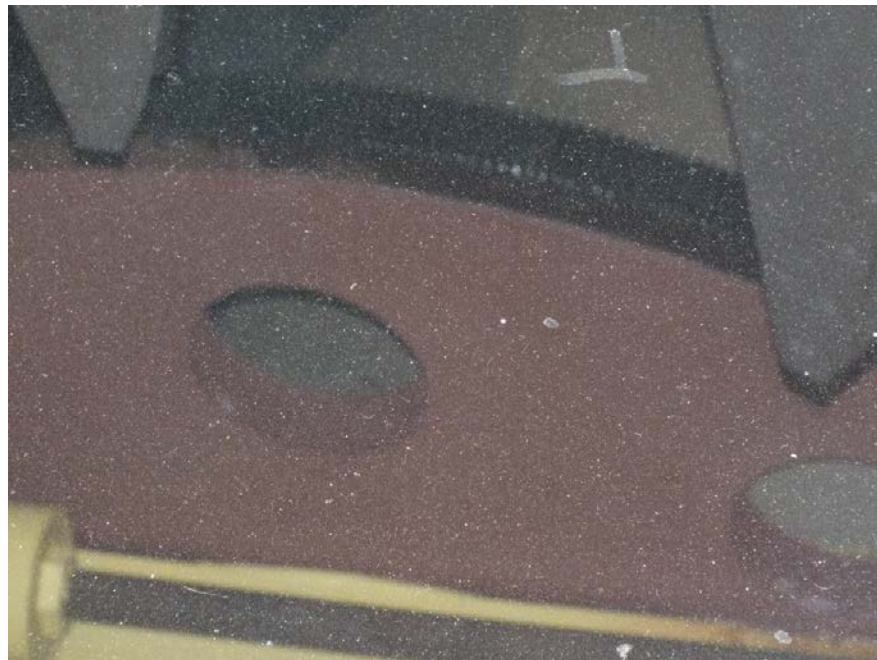
Shane 120" Primary

The 120" primary was dustier than we had been seeing lately, which may be due in part to its not having been CO₂ cleaned in 4 months. This, in turn, was due to an EH&S concern that the scaffolding system used in the process was inadequate. On the plus side, there weren't too many oil spots. There were a few bird "strikes," though.

We measured the reflectivity to be 86% in the red and 82% in the blue, relative to the reference mirror.

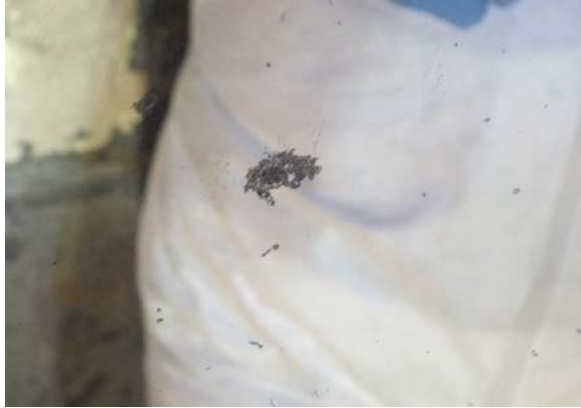
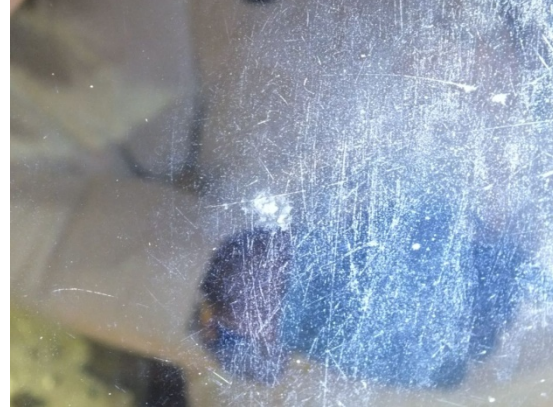
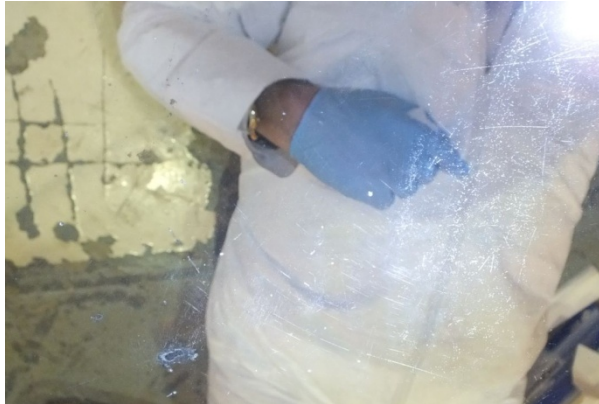
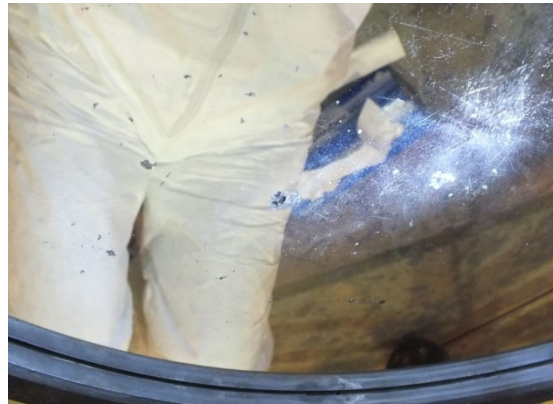
The Coude secondary mirror seemed to have developed new coating blemishes, or existing ones had grown larger. Attempts to clean small regions showed it to be ineffective. The mirror was measured to be 88% reflective in the red and 87% in the blue.

On this trip we encountered a lot of dusty optics but few surprises. The deteriorating condition of the Coude Secondary and the water spots on the aperture plate in the slit room stood out for me.

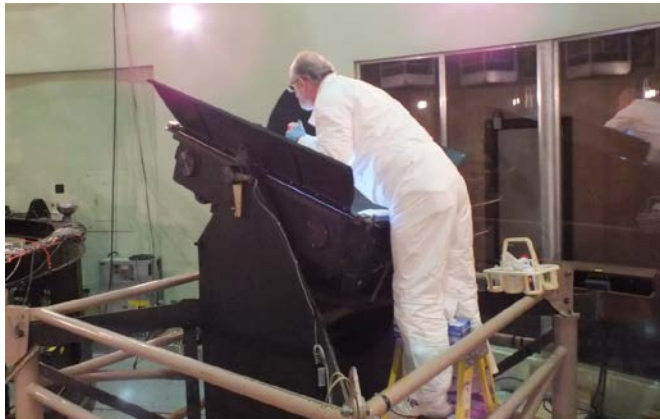
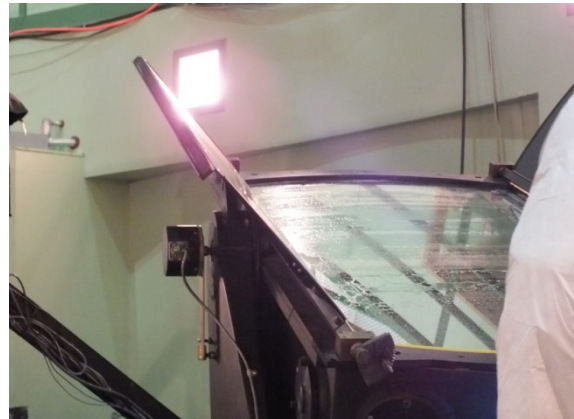
Coude #3

Coude mirror #3 was on the dome floor. It was dusty so Dave cleaned it with Orvus/acetone/H₂O, then just H₂O, followed by ethanol and then acetone. It was very cleanable, in that it was robust. We measured 91% reflectivity in the red before cleaning and 94% after. With the blue filter it was 86% before and 88% after.

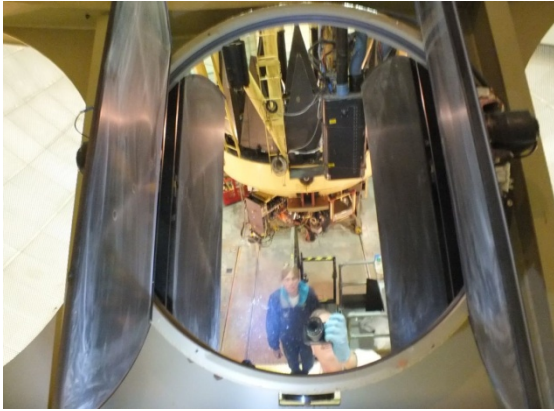
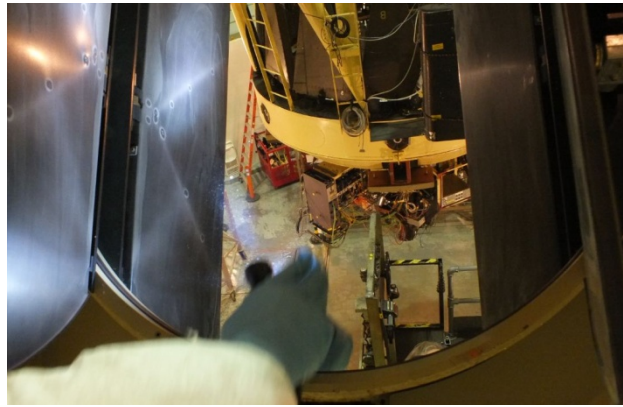
Coude #4

Coude mirror #4 was not too bad. It is downward-facing and it sounds like it hadn't been used too much, lately. We measured 94% reflectivity in the red and 93% in the blue.

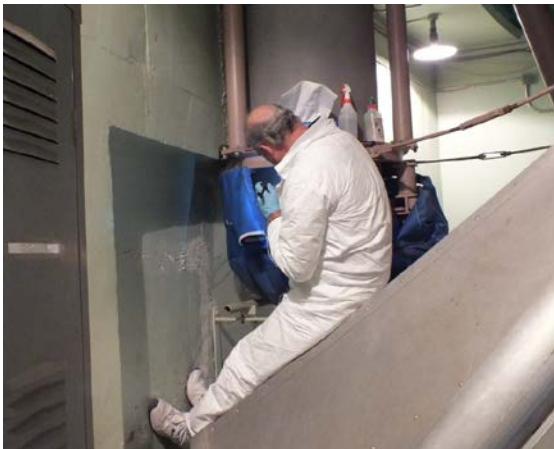
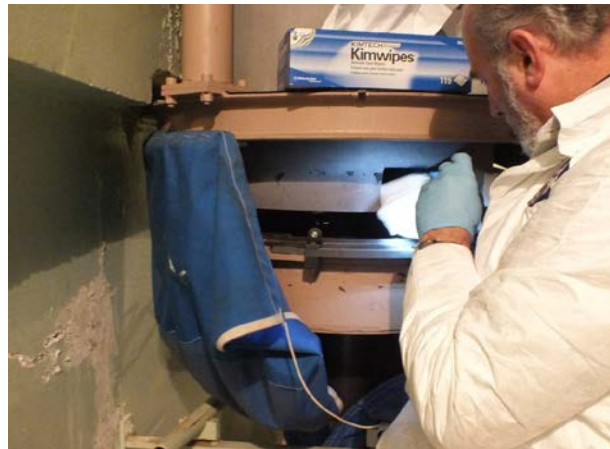
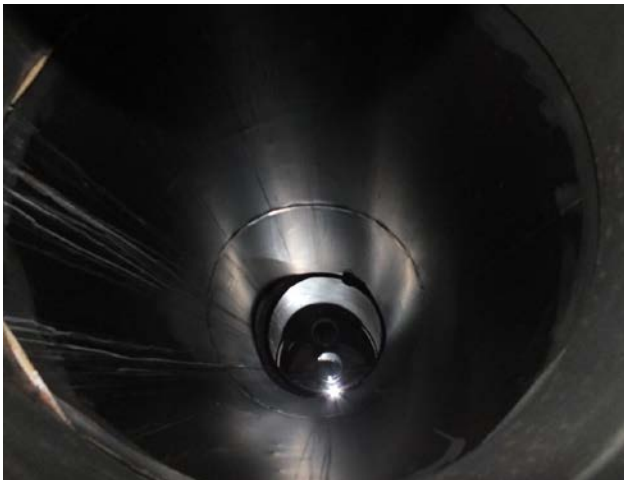
CAT Primary

The Coude Auxiliary Telescope's upward facing primary mirror was as dirty as usual, and maybe more so. Access for cleaning is very difficult, as can be seen in the photos. Nevertheless, Dave cleaned it with compressed air, then H₂O, then ethanol, then acetone. We made an attempt to get the reflectometer in through the access hole before deciding that it wasn't worth the risk of scratching the mirror.

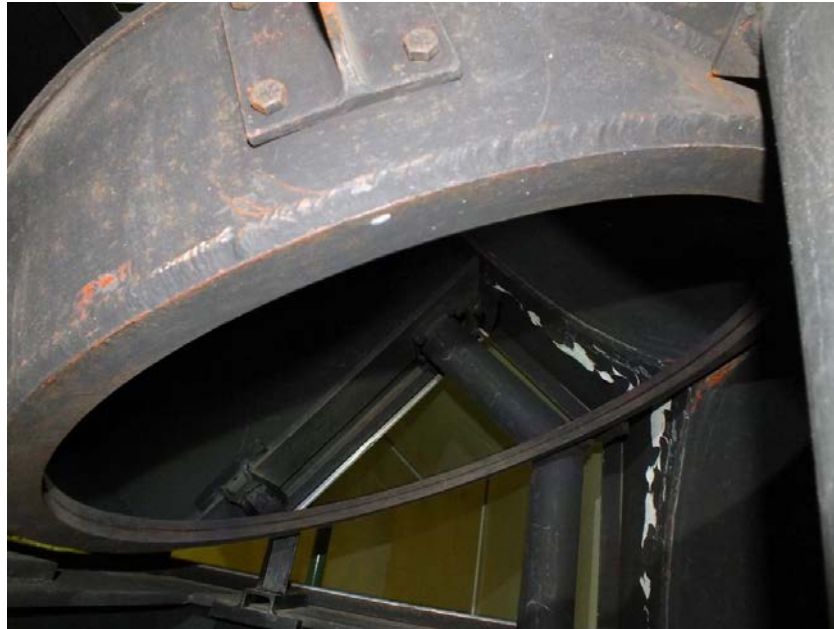
CAT Fold Flat

This 45 degree downward facing mirror did not look like it could be improved upon by cleaning, so we left it alone. We did measure the reflectivity to be 86% in the red and 84% in the blue.

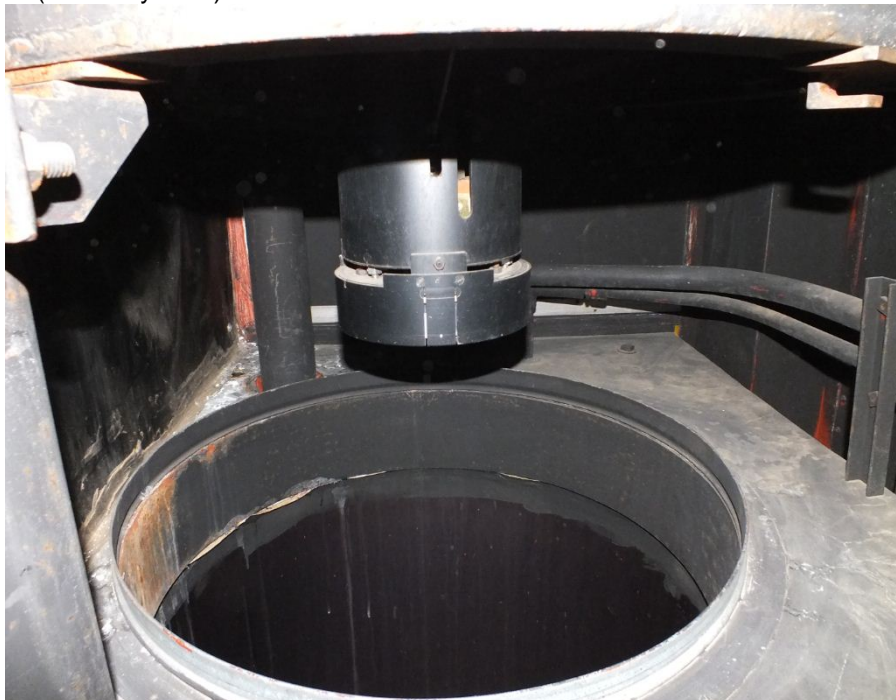
CAT Secondary

The downward-facing secondary was not cleaned. We did measure 48% reflectivity with the red filter and 69% with the blue. These low numbers could be due to the curvature of the mirror exceeding the limits of the reflectometer (it's always low).

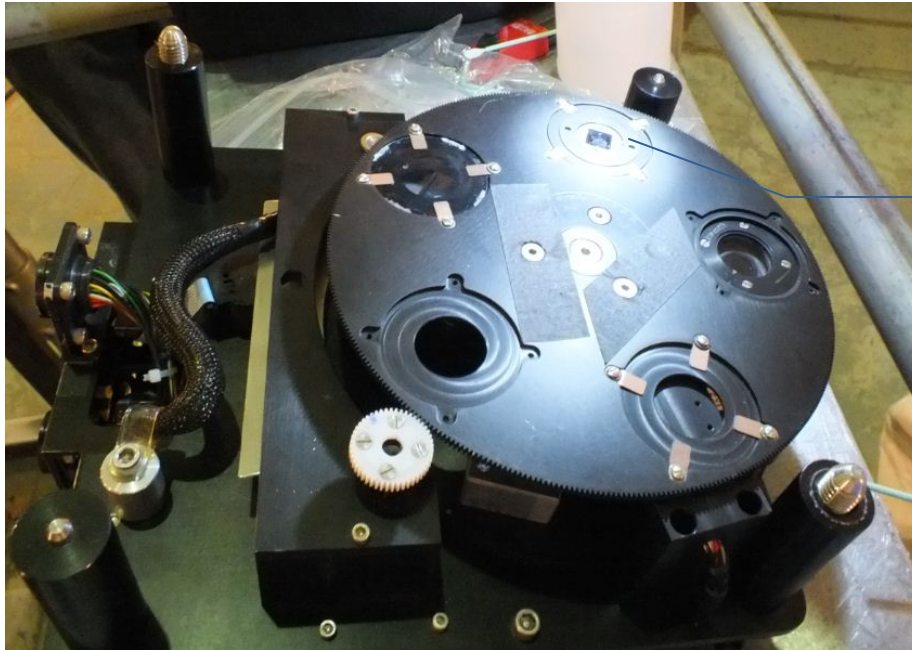
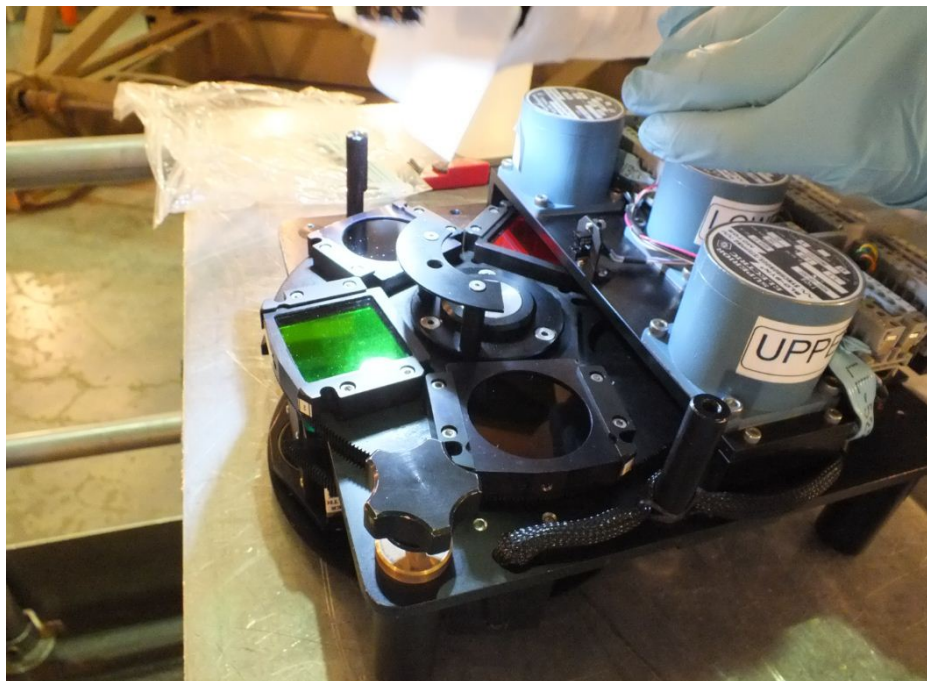
KAST Waveplate

This optic was a film, rather than being glass, and was installed in the back side of the fixture that holds the red side filters. It had been flagged because of a large spot covering half the square centimeter or so of the waveplate's total area. Dave tried to clean it with water on a Q-tip but to no avail. It may have been caused by acetone melting the film on a prior cleaning attempt. Dave cleaned other optical surfaces in the accessory, including the glass filters on the other side, which were removed by sliding outward.

Waveplate
(Spot
Visible)

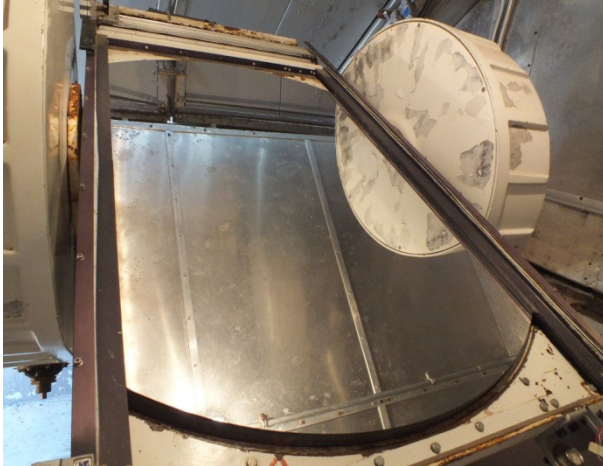
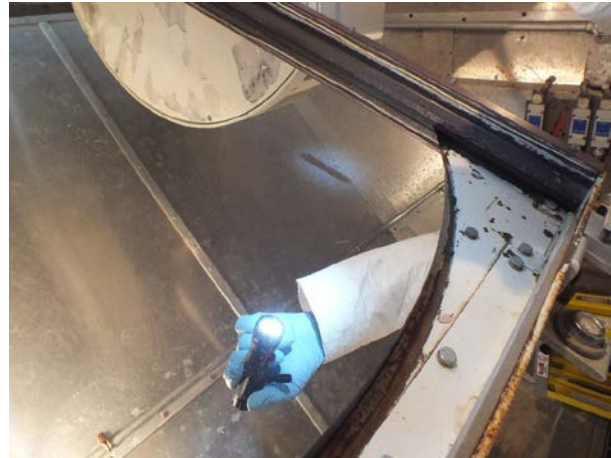
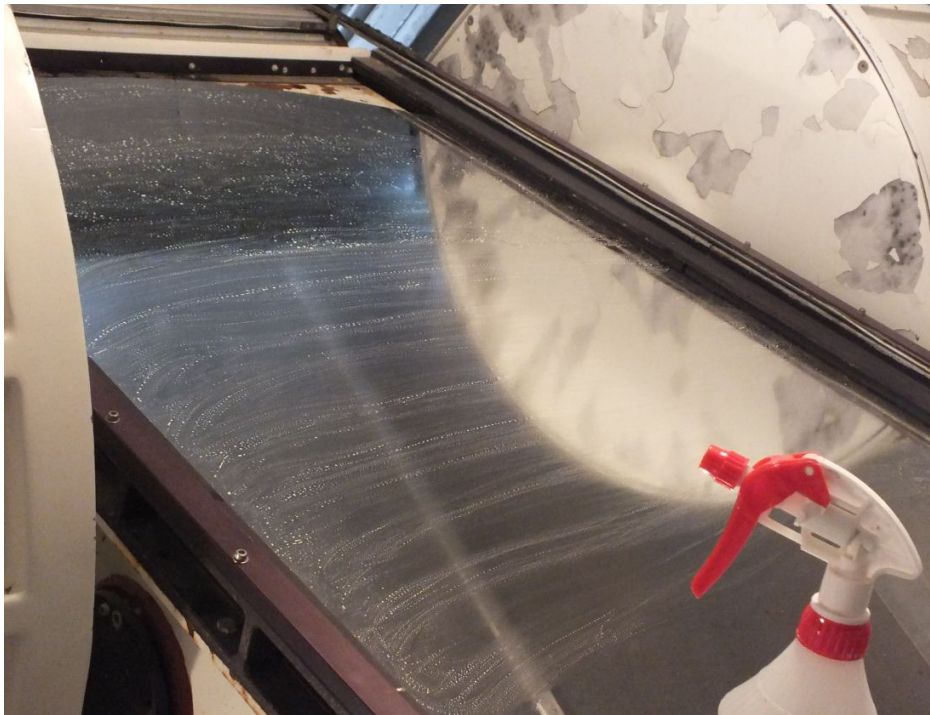
Coude #1

This was the large mirror out in a shed next to the 120" dome. It was very dusty, as can be seen by the finger mark in the dust in the second image. We measured 83% reflectivity in the red and 87% in the blue before cleaning. Dave blotted with Orvus/acetone/H₂O then rinsed with more H₂O, followed by ethanol and acetone. After the first acetone application it was slow to evaporate; Dave applied another round and it was clean afterwards... it may have just needed more time after the first application, but in any case the second acetone application left it quite clean. We measured 86% reflectivity in the red afterwards and 93% in the blue.

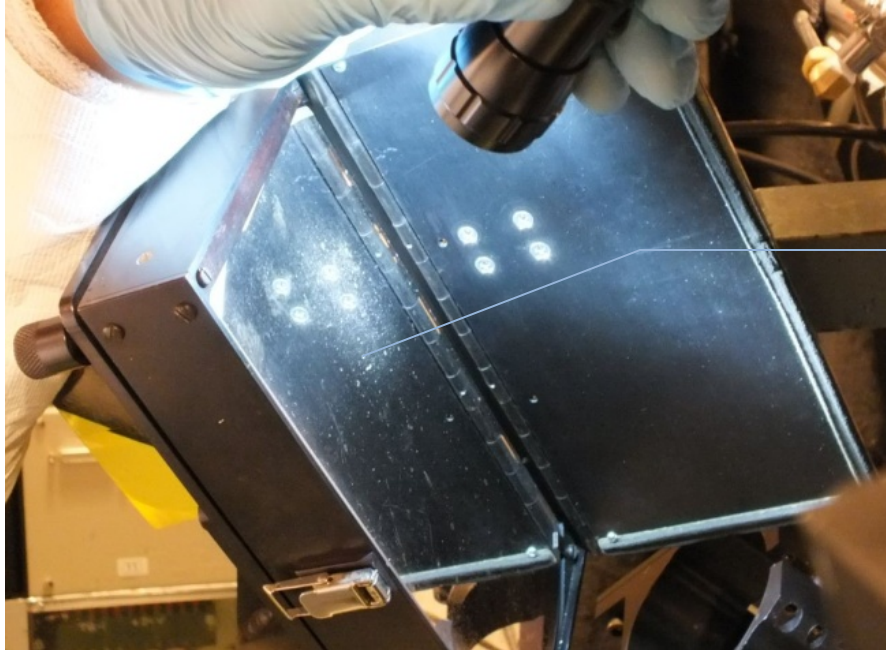
Pick Off
Mirror (After
Cleaning)

Dave cleaned the pick-off mirror in the slit room... it didn't sleek but it didn't get much cleaner, either. What was left was in the coating. He also tried cleaning the aperture plate but there were water spots from a leak event that wouldn't come off. He also blew off the filters in a wheel using canned air.

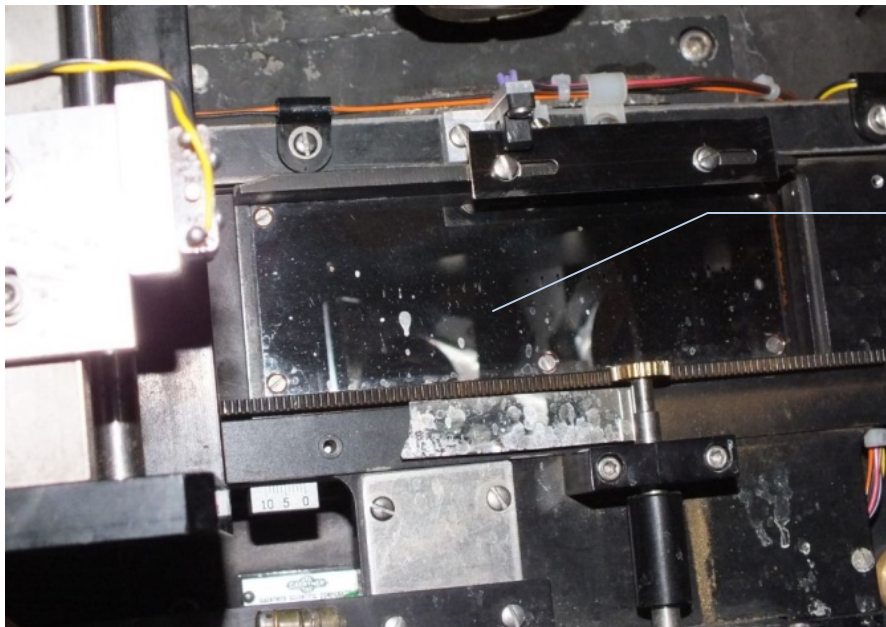
Aperture
Plate with
Water Spots

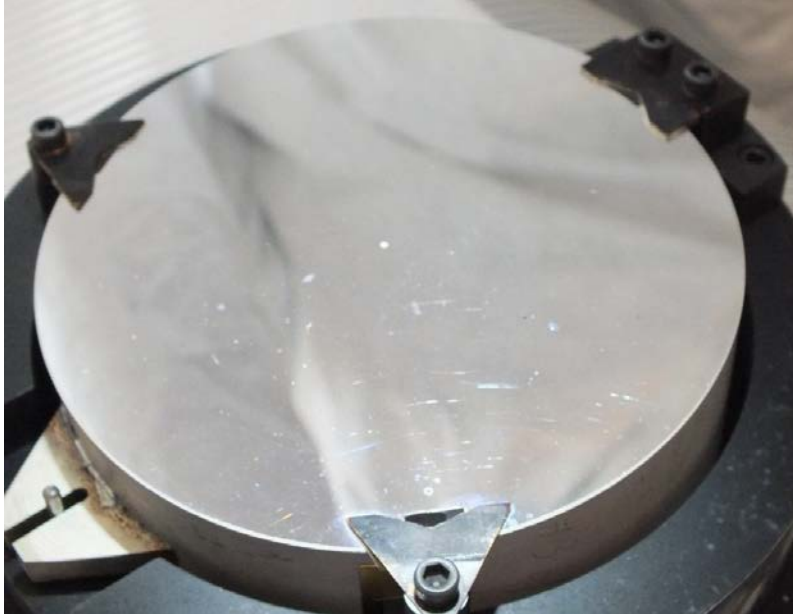
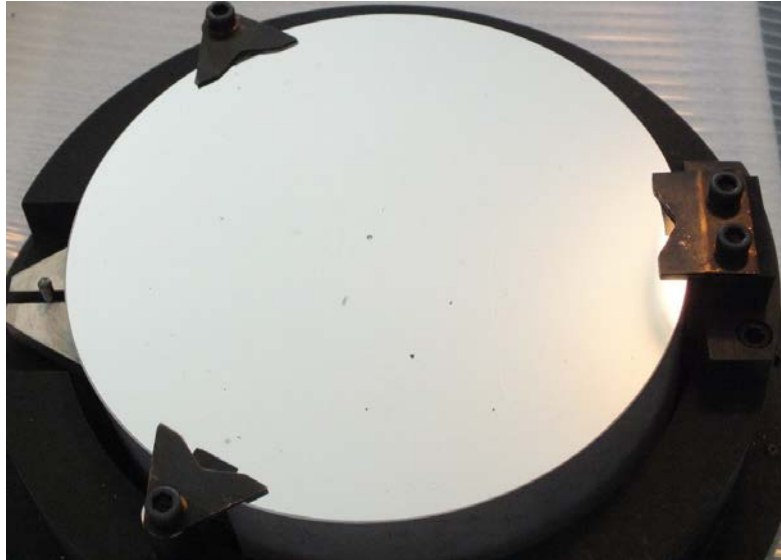
KAST Red Collimator

The KAST red collimator was brought into the Gemini room of the dome, where we often clean filters, et cetera. It was a little sleeky, but Dave was able to clean dust off it without adding to them. The dot in the center of the mirror is for alignment.
