Mt. Hamilton Optics Cleaning Trip
David Hilyard and Brian DuPraw
8/17/12

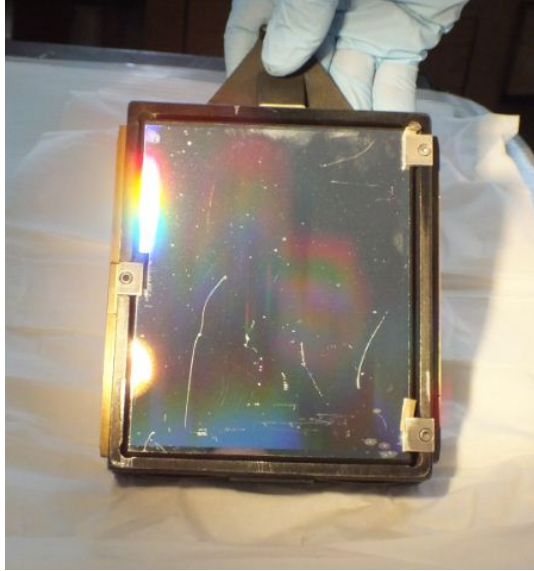
Grating 1 - 5000 A, 600 line/mm

The KAST gratings seemed little changed from the last time they were inspected... most had a few scratches. Cleaning was limited to blowing them off with canned air, however.

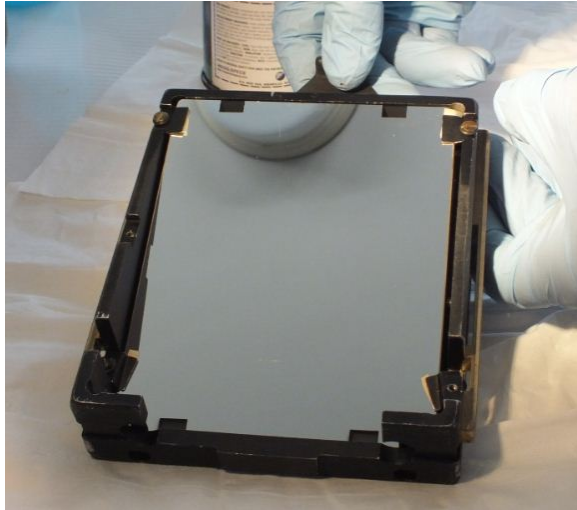
The KAST flat mirror had some fingerprints along the top edge but Dave was able to clean them with ethanol and acetone. The round collimator mirror was dusty and also had some surface spots so Dave attempted to clean it with acetone on a Kaydry; however, he stopped when it became apparent that the coating was too soft to stand up to cleaning.

KAST Flat Mirror – Cleanable

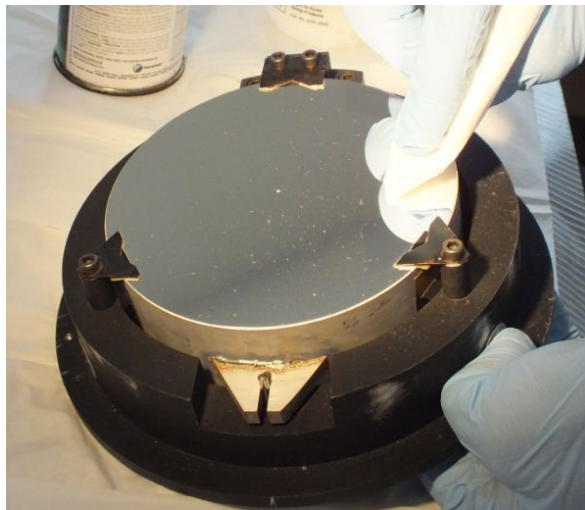
KAST Collimator – Cleaning Attempt

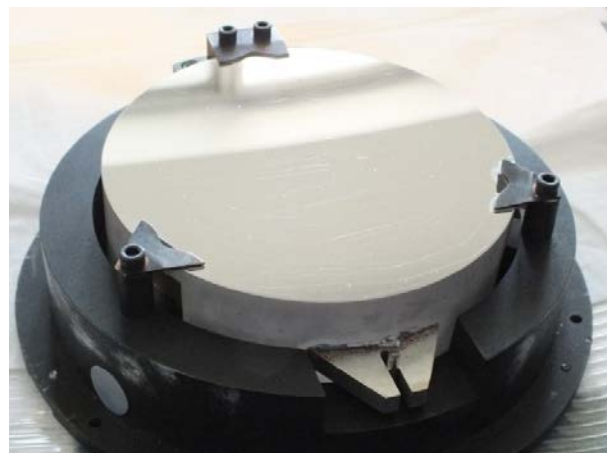
Cleaning Stopped due to streaks forming

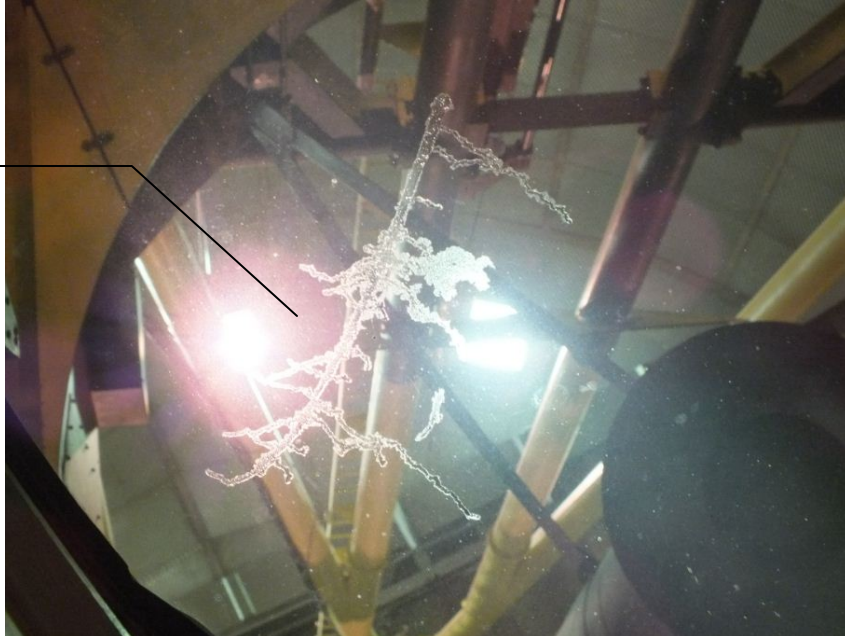
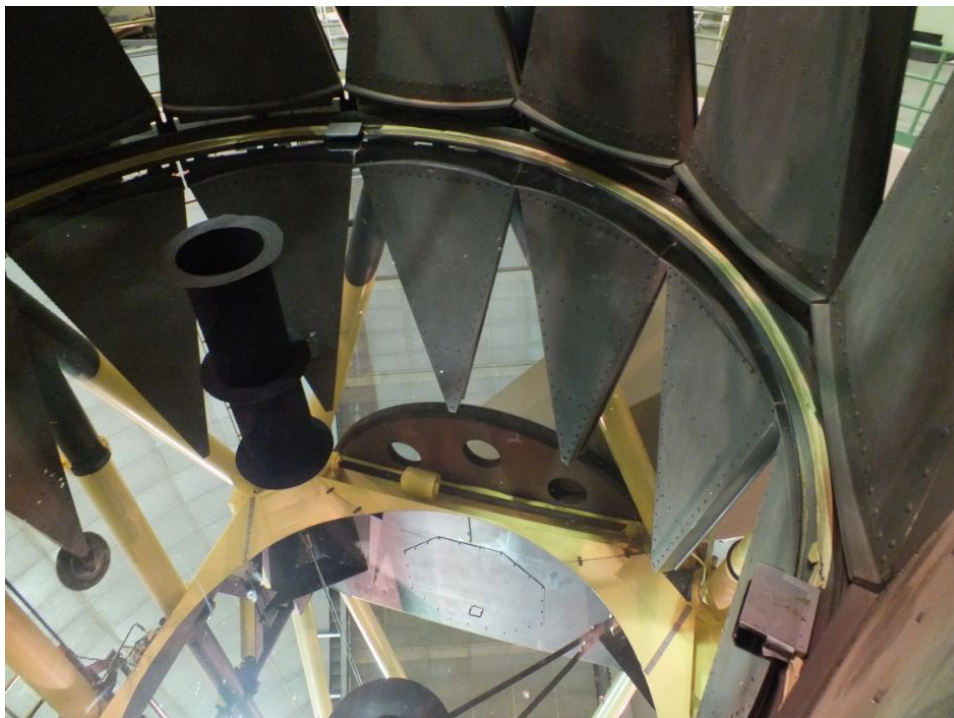
The 120" primary mirror had a 12" long oil streak which was luckily close enough to the edge of the mirror that Dave was able to clean it. (No small feat, anyway, given the way the pie-shaped cover segments form a fence around the mirror when they're open). Other than the oil spot the mirror condition looked pretty good. After he cleaned the oil spot we measured 88% reflectivity in the blue and 96% in the red (relative to the reference mirror).

Oil Spot

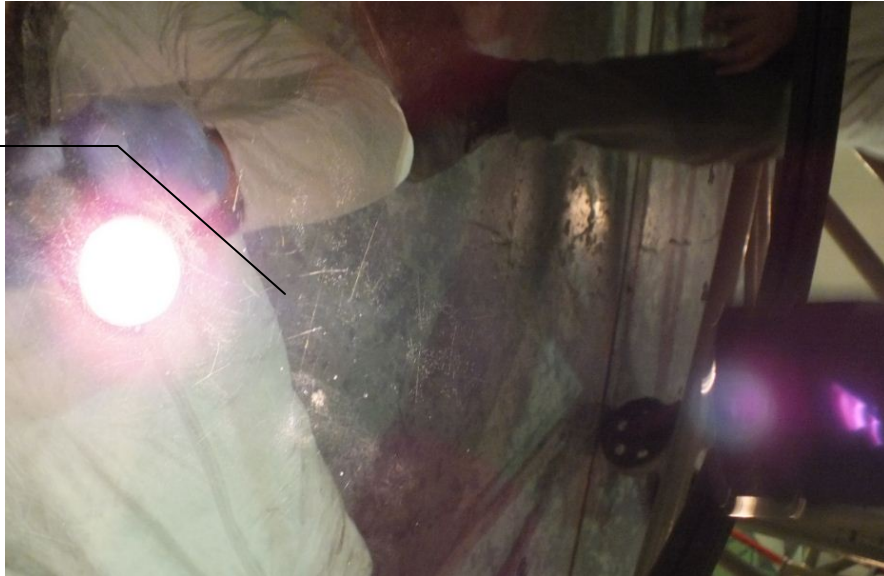
The Coude secondary mirror had a lot of spots in the coating itself. Dave tried cleaning an area and, although it didn't sleek the mirror, neither did it help. We measured 87% reflectivity in the red and 90% in the blue.

Poor
surface

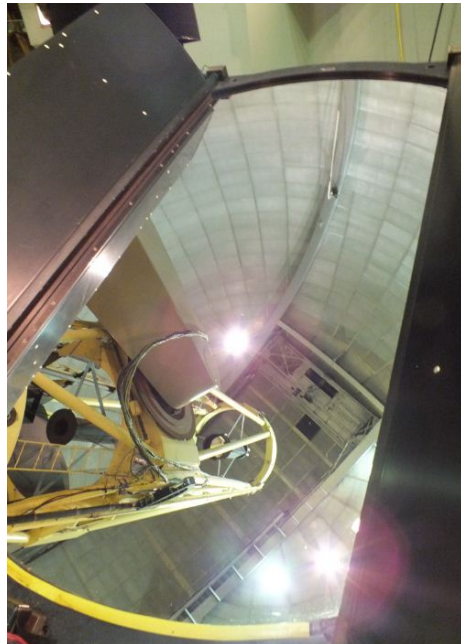
The third mirror in the Coude chain was the large flat mirror often found in its fixture on the dome floor. It looked good, though a little dusty, so Dave blew the surface off with canned air. We measured 91% reflectivity in the red and 90% in the blue.

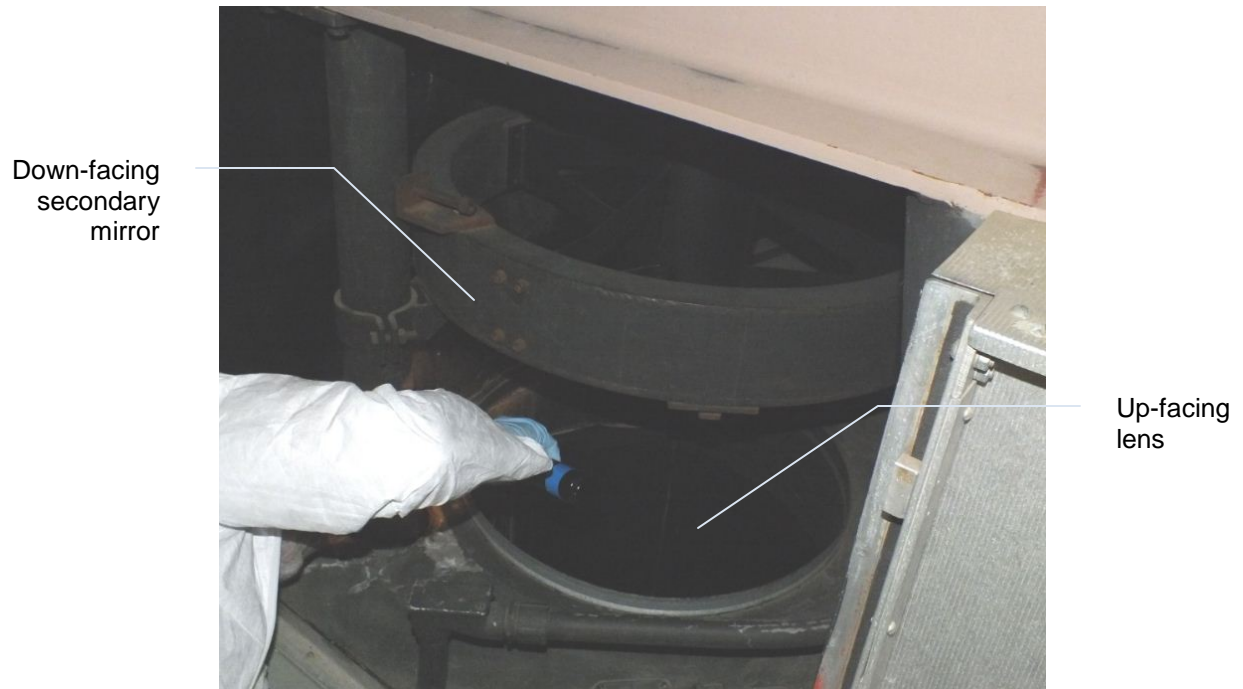
The Coude Auxiliary Telescope's primary mirror is difficult to access but is usually found to be dirty since it faces straight up. Dave cleaned it with de-ionized water on a Kaydry, followed by ethanol. Then he used acetone to cut any streaks the ethanol might have left, even though the limited visibility available made their presence just an assumption. The small opening in the side cover also makes it risky to measure the reflectivity so we didn't do that this time. However, the downward-facing secondary was measured to have 58% reflectivity in the blue and 61% in the red. It has always had very low reflectivity numbers.

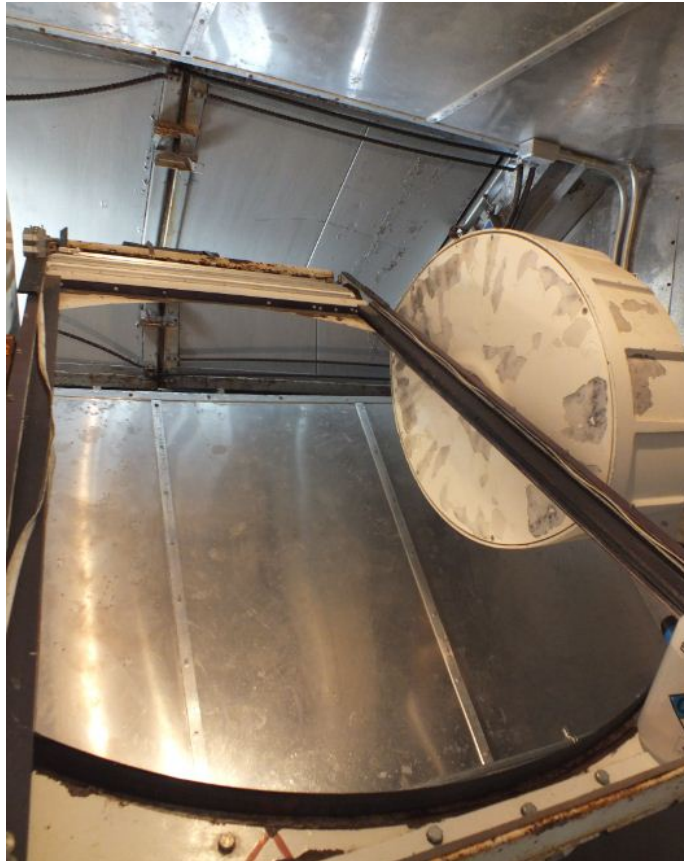
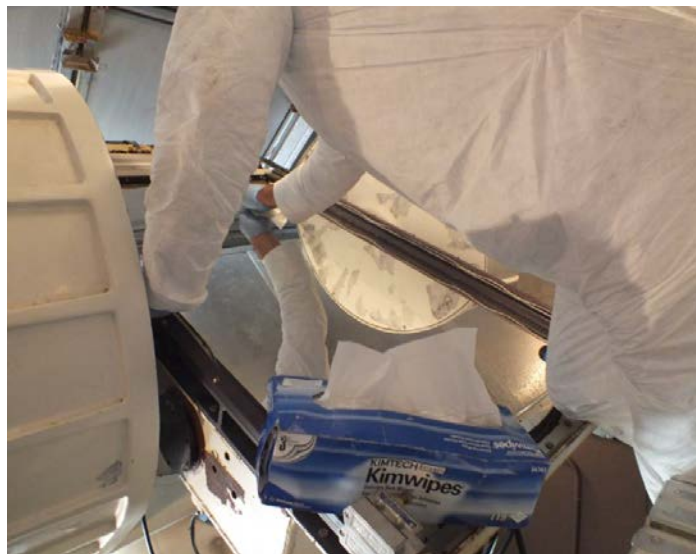
The large siderostat, accessible from outside the dome, was not too bad, overall, (no mouse prints), but could stand to benefit from cleaning so Dave did just that. He sprayed on de-ionized water and then dabbed on an Orvus/acetone/H₂O mix, followed by ethanol. Afterward we measured 89% reflectivity in the blue and 88% in the red.

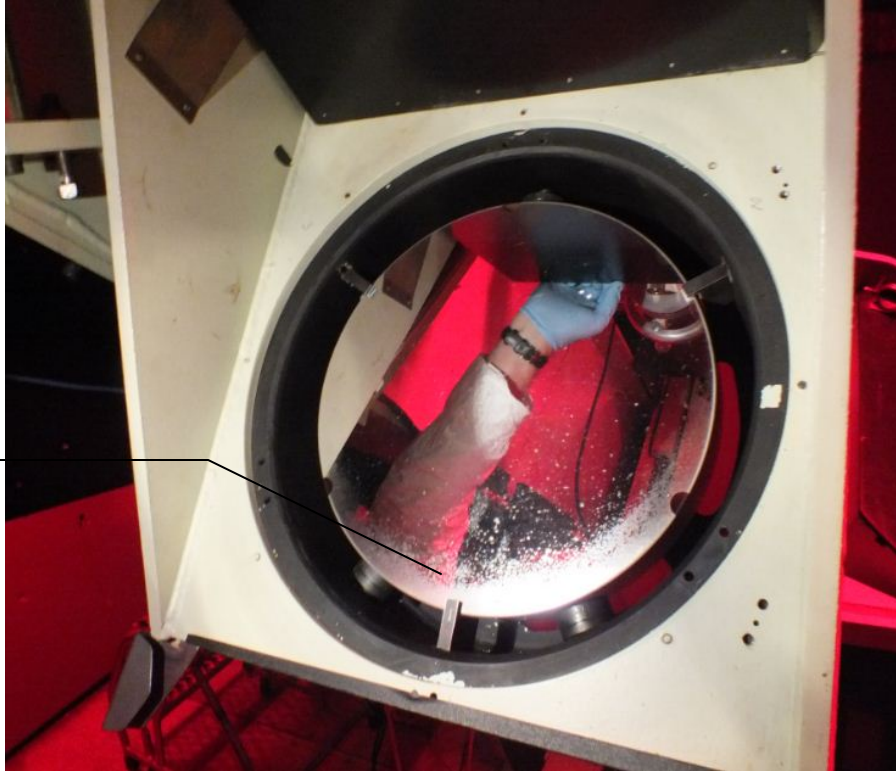
The Hamilton Collimator usually is seen to have surface discoloration on the right side. This time we saw new and fairly severe degradation of the coating, seeming to be working its way in from the bottom edge upward. It was clearly not the sort of degradation that could be cleaned away.

Severe
edge
degradation

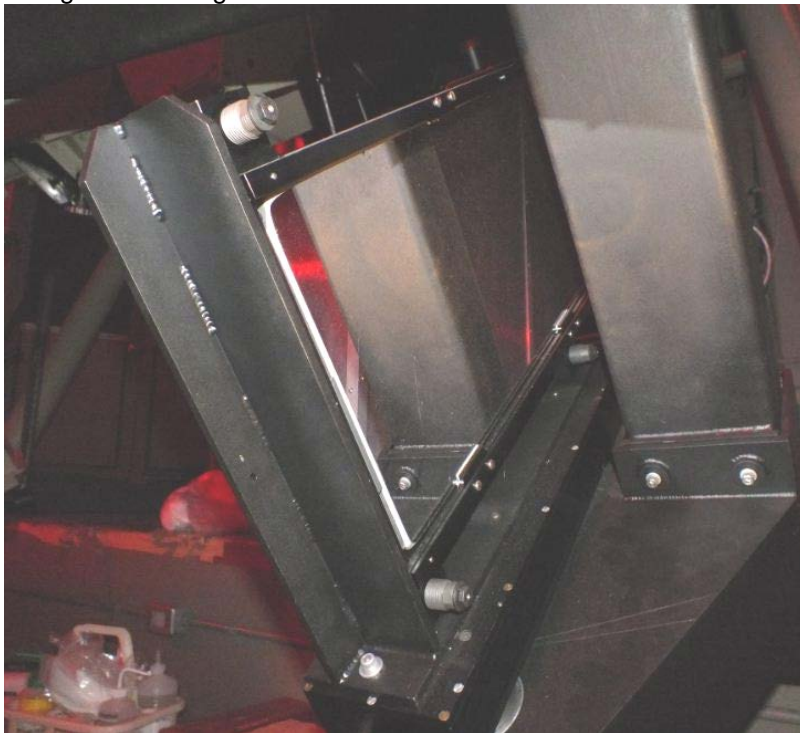
This flat mirror benefited from being blown off, but when a tiny area was cleaned it was immediately apparent that the coating was too fragile to continue.

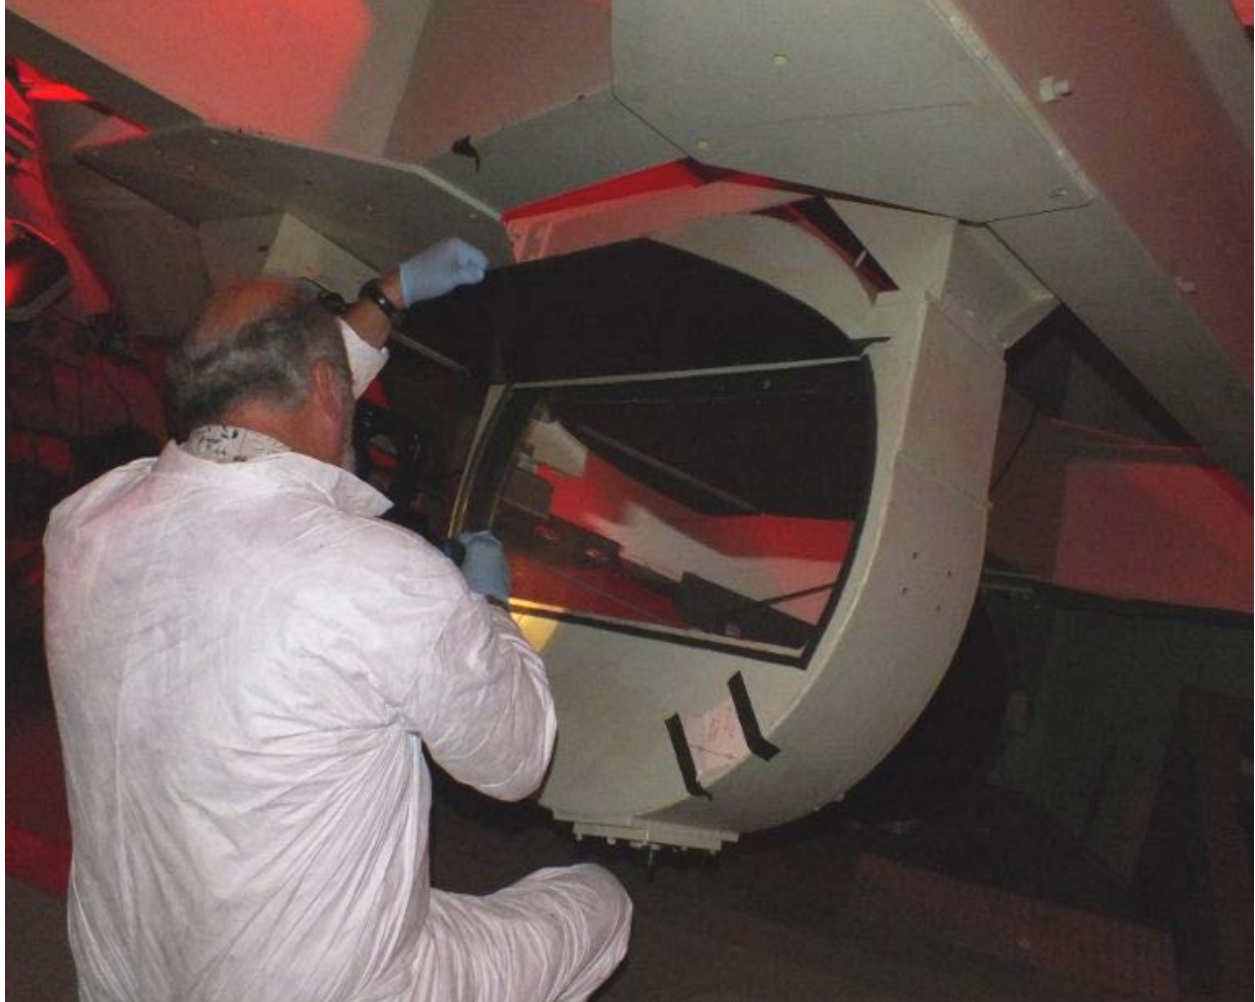
There was one mirror that had always been covered and we had never looked at before. This time we opened the cover to inspect it and found it was a little dusty but in good condition. Later we asked Kostas about it and he said that mirror was not in general use.

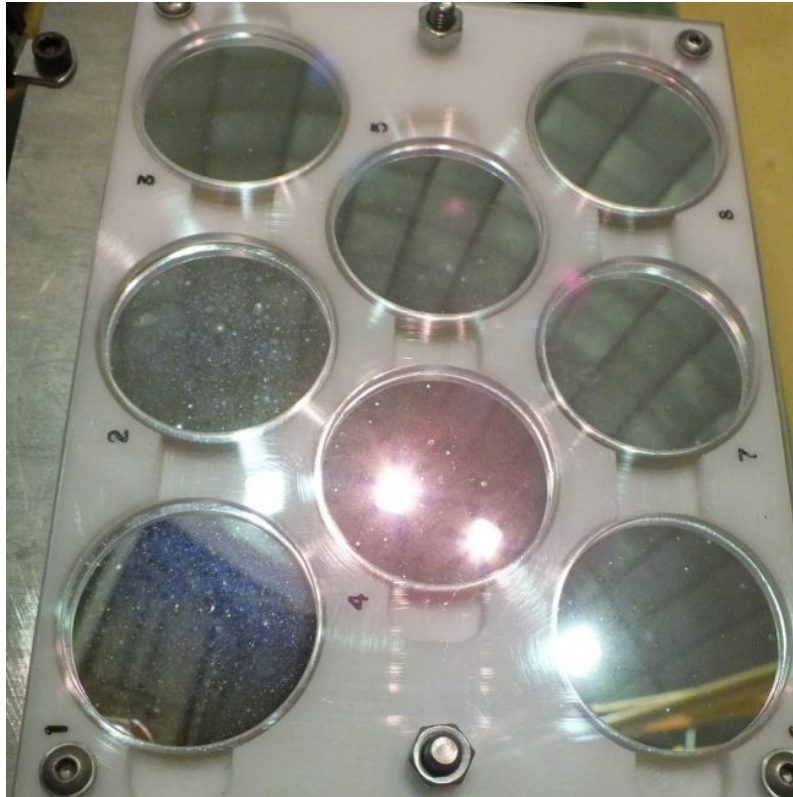
The protected silver coating samples we had made in Santa Cruz had been brought down from the mountain a couple of months prior to this trip for a closer inspection, and then returned for the past month or so. In general they were holding up very well. We were informed that they had been CO₂ cleaned a couple of days ago.

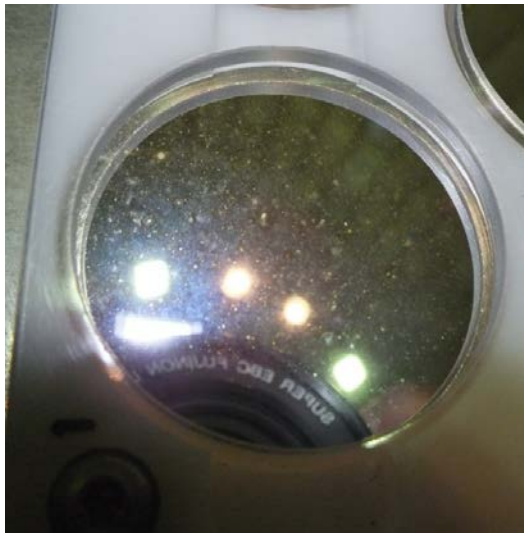
Coating Sample 1

Of the eight samples in the top half of the rack, most had a few nuclei of degradation. Disks 7 and 8 had the least nucleation sites but had an overall scattering haze. Disks 1 and 2 seemed to have both.
