The Coude secondary mirror. The last aluminization was 5 years ago.

**JULY 9, 2002**

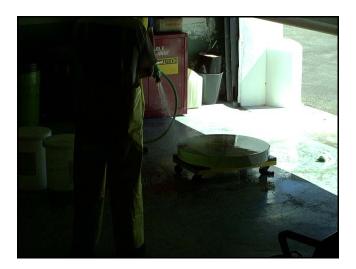
In areas where aluminum resists removal (this mirror is SIO overcoated, making stripping more difficult), a technique is to lay Kaydrys on the surface and saturate with stripping solution, and allow to remain for a time. Don't allow to dry, however.

After awhile, all traces of aluminum will be gone. Again, after this process, rinse with tap water.
