Tuning a 2.4 Meter Telescope... Blindfolded

^aUniversity of California Observatories, Santa Cruz, CA 95064 USA

ABSTRACT

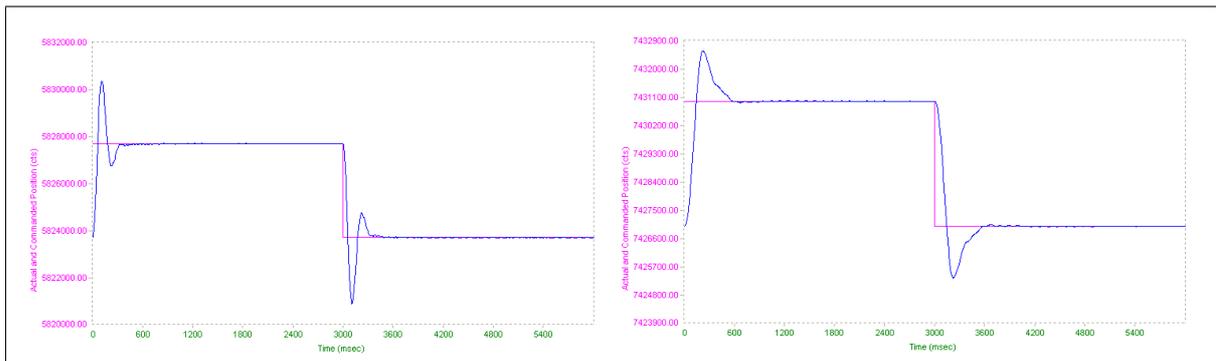
Figure 9. Final step response profiles, azimuth and elevation axes

Further iteration would then occur on the derivative and proportional terms, trying to increase the proportional term as much as possible without inducing ringing. At high enough values, the derivative term introduced its own instabilities, usually in the form of high-frequency noise (see figure 8). The derivative term is also sensitive to quantization of encoder signals and encoder noise in general; properly setting the gain on the servo amplifiers and mitigating noise on the encoder feedback signals was crucial to opening up the parameter space.

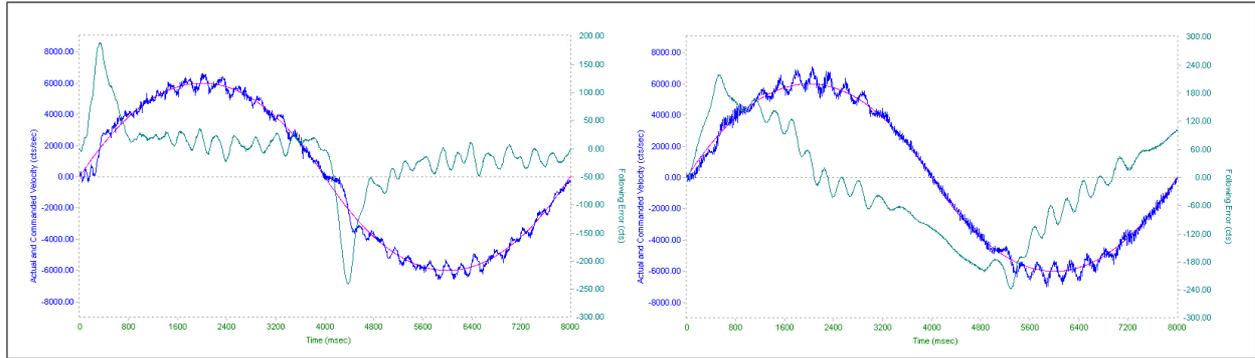
Figure 10. Final parabolic response profiles, azimuth and elevation axes

test, and indeed, the following error was minimized with a term value some 20% higher than the final derivative term, at least for the azimuth axis. The elevation axis received one less round of optimization, as its performance had already reached an acceptable level. Note in figure 10 how the following error for the azimuth axis hovers around zero for most of the move, while the following error for the elevation axis takes longer to converge to zero; this is largely due to the absence of a velocity feed-forward term for the elevation axis.

The suitability of the parameters determined via the step response tests would then be probed on a parabolic response test (see figure 10). The two parameters that saw the most adjustment in the parabolic response test were the integral and velocity feed-forward terms, with the objective of minimizing the following error as the telescope moved through its commanded velocity track. The results of the parabolic response tests were particularly interesting for our needs, as the nature of this test more closely mimics the use case that we care about: precise velocity tracking at low and constantly varying speeds.

Throughout most of the tuning effort, adjustments to the velocity feed-forward term did not have the expected effect. For simple motor systems, the velocity feed-forward term is expected to be roughly the same as the derivative term. When set too high, the velocity feed-forward term inverts the phase of the following error vs. time plot, such that the following error is out of phase with the commanded velocity profile. It was not until the very last round of tuning that the velocity feed-forward term provoked a phase change on the parabolic response

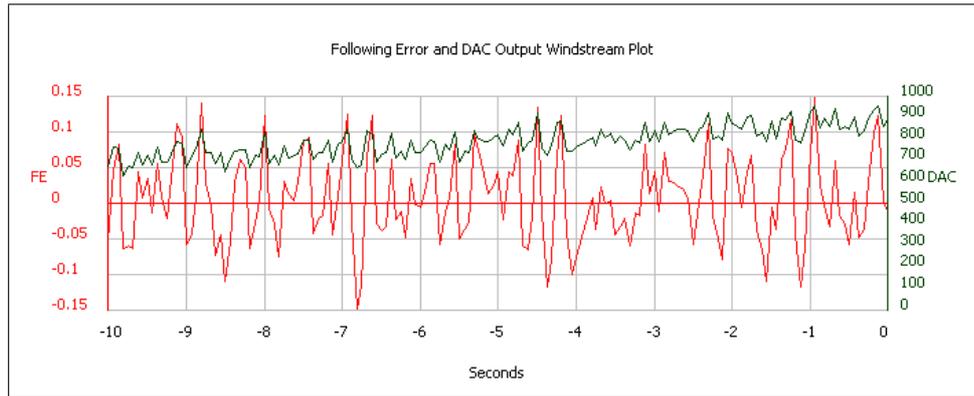
Figure 11. Azimuth tracking performance at 0.01 degrees/sec; following error (FE) is in arc seconds
