Mt. Hamilton Optics Cleaning Trip
David Hilyard and Brian DuPraw
8/17/12

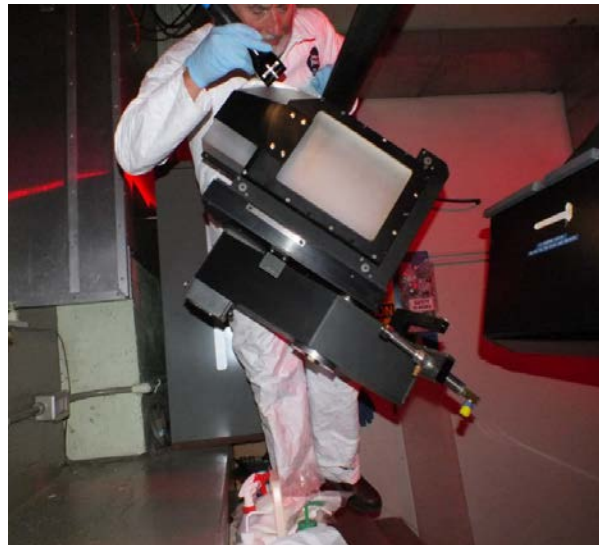
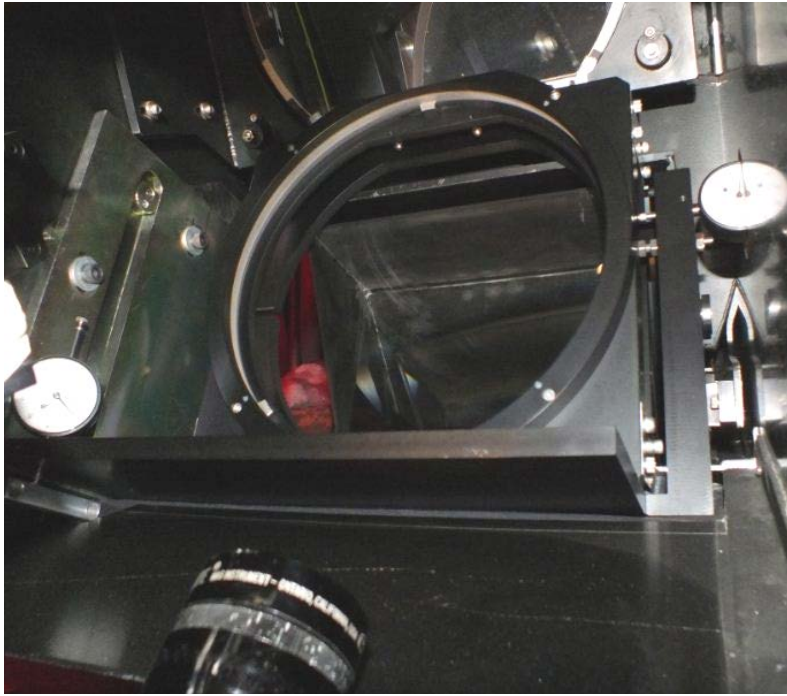
Dave inspected other components of the camera, such as the prisms, mirror and an easily-sleeked lens. They were all blown off with canned air.

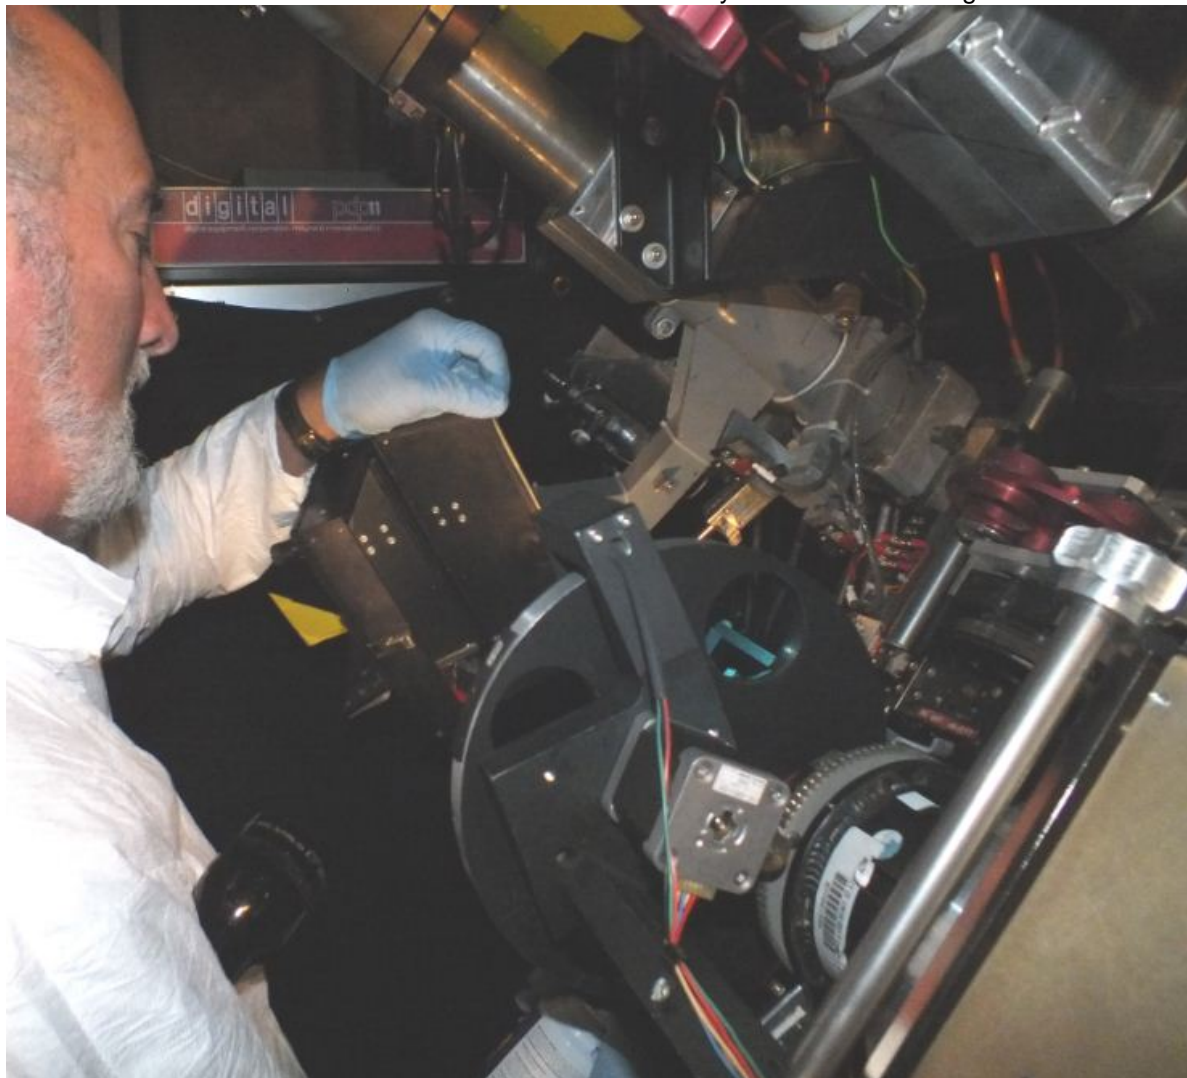
Slit Room

In the slit room Dave blew off a number of surfaces but they didn't need cleaning with solvent.
